36 New Road, Hertford, Hertfordshire,
England, SG14 3JL

This report contains

Schedule of Cleanliness and Condition

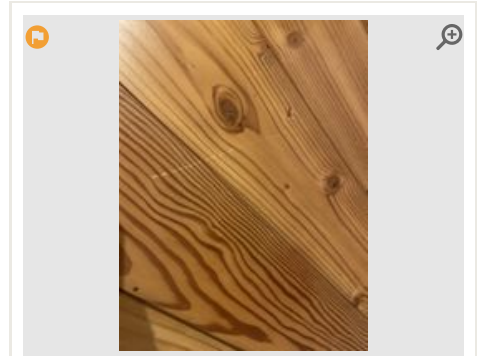
Provided by	Tenant
Captured (Certified by inspector)	01/12/2023
Added	06/12/2023
Reference	4.2.2

Item	Description	Condition	Cleanliness	Photos
4.1 General Overview	Clean and tidy. Neutral smell (no smoking or pet odours).	● Good	● Good	📷 9 photos
4.2 Door (Internal)	For any marks, scuffs or scratches to front side and reverse please see pictures.	● Good	● Good	📷 6 photos
	🚫 Disagreed by tenant - 6th December 2023 Information provided by tenant Scratch on hallway side		● The inspector agreed

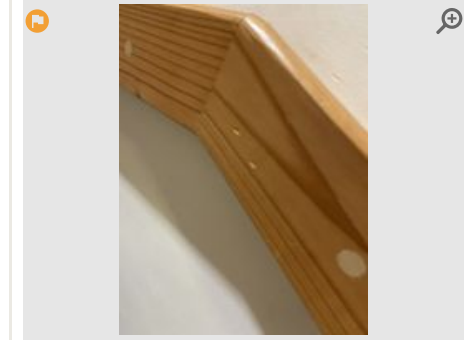
Provided by	Tenant
Captured (Certified by inspector)	01/12/2023
Added	06/12/2023
Reference	6.2.2

Item	Description	Condition	Cleanliness	Photos
6.1 General Overview	Clean and tidy. Neutral smell (no smoking or pet odours).	● Good	● Good	📷 9 photos
6.2 Bannister/Hand Rail	Appears securely fixed and intact. Free of marks and scratches.	● Good	● Good	📷 9 photos
	Disagreed by tenant - 6th December 2023		● The inspector agreed	
Information provided by tenant More marks and chips than documented
