36 New Road, Hertford, Hertfordshire,
England, SG14 3JL

This report contains

Schedule of Cleanliness and Condition

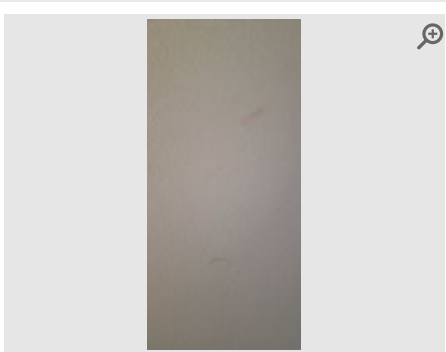
Provided by	Inspector
Captured (via App):	01/12/2023 10:56 AM
Added	01/12/2023
Reference	1.6.1

N/A
1.6 Walls	For any marks, stains, scuffs, picture hooks, raw plug or filled holes present please see pictures.	● Fair	● Fair

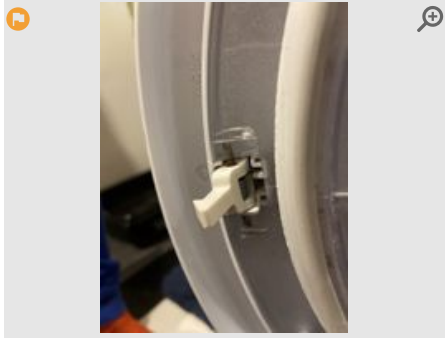
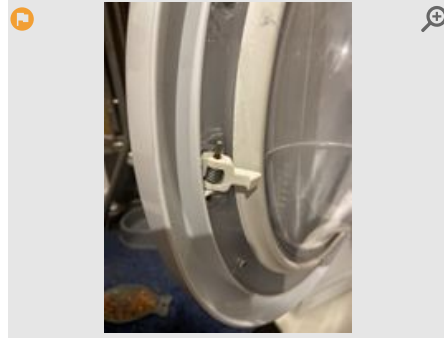
2.10 Tumble Dryer	Seal is clean and intact. No signs of damage to drum inside. Door hinge is functioning smoothly.	● Good	● Good	📷 4 photos
	🚫 Disagreed by tenant - 6th December 2023		● The inspector agreed	
	Information provided by tenant The plastic catch to lock the door is broken (will report separately)

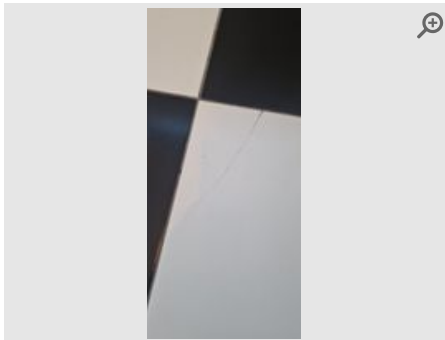
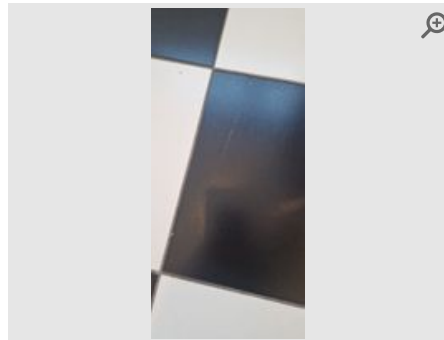
2.11 Floor	For any stains, marks, cracks, chips, scratches or indentations please see pictures.	● Fair	● Good	📷 2 photos

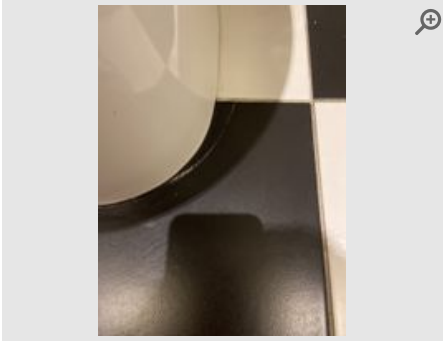
Provided by	Tenant
Captured (Certified by inspector)	01/12/2023
Added	06/12/2023
Reference	3.7.1

3.7 Floor	For any stains, marks, cracks, chips, scratches or indentations please see pictures.	● Good	● Good	📷 1 photo
	<div style="display: flex; justify-content: space-between;"> 🚫 Disagreed by tenant - 6th December 2023 🚫 The inspector disagreed </div>			
	Information provided by tenant Adhesive mark around base of toilet

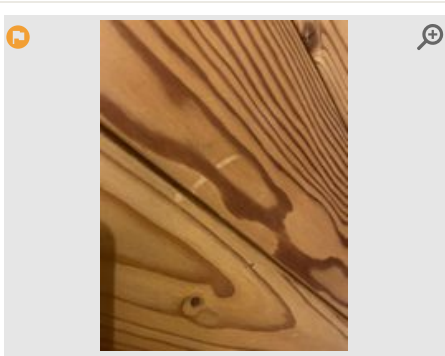
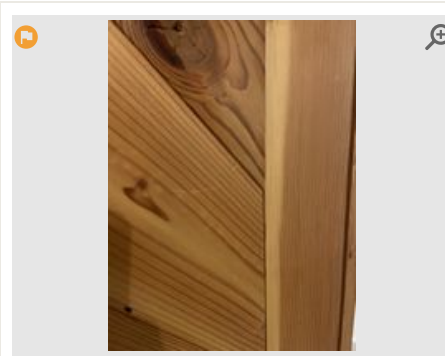
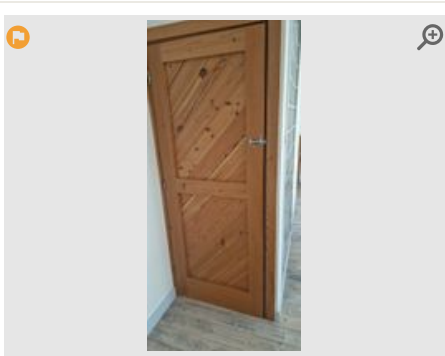
Provided by	Tenant
Captured (Certified by inspector)	01/12/2023
Added	06/12/2023
Reference	4.2.1

Item	Description	Condition	Cleanliness	Photos
4.1 General Overview	Clean and tidy. Neutral smell (no smoking or pet odours).	● Good	● Good	📷 9 photos
4.2 Door (Internal)	For any marks, scuffs or scratches to front side and reverse please see pictures.	● Good	● Good	📷 6 photos
	🚫 Disagreed by tenant - 6th December 2023 Information provided by tenant Scratch on hallway side		● The inspector agreed

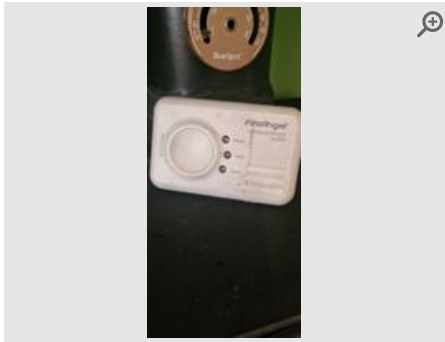
Provided by	Inspector
Captured (via App):	01/12/2023 11:10 AM
Added	01/12/2023
Reference	4.10.1

4.10 Carbon Monoxide Alarm	No expiry date present. Note to tenant, by signing this document you are acknowledging that you have tested the alarms on the day of the tenancy commencing.	● Very Poor	● Good	📷 1 photo
	🚫 Landlord responsibility		🔄 Replace

Name	Status
Living Room/Lounge	
Carbon Monoxide Alarm	🔧 Landlord responsibility 🔄 Replace

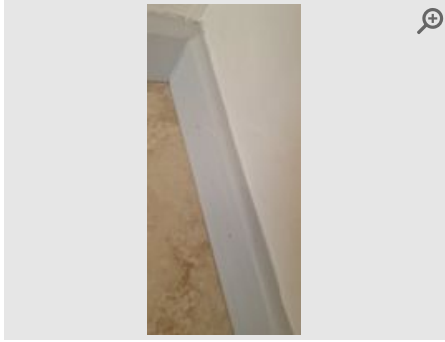
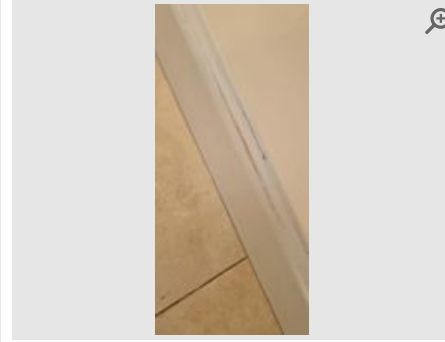
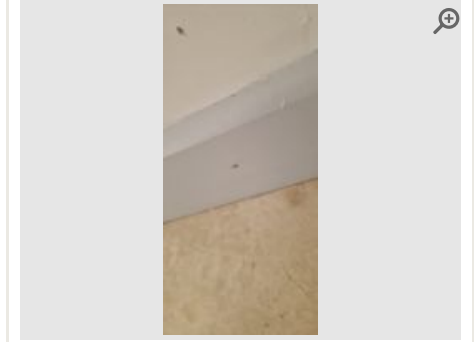
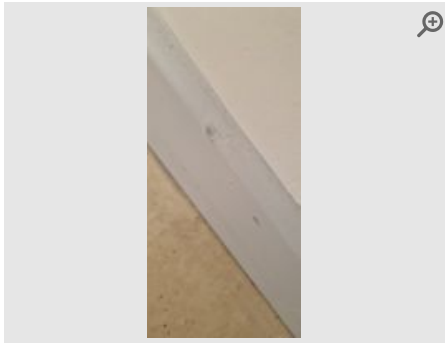
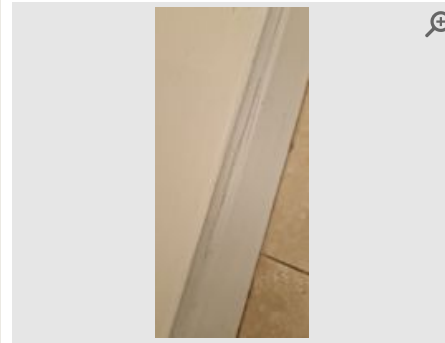
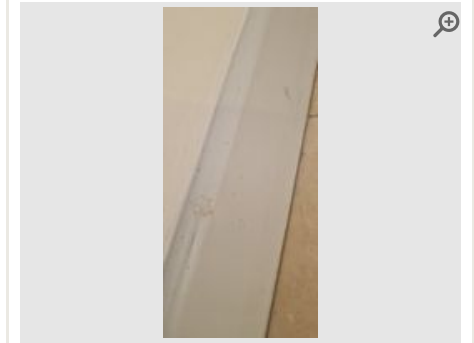
Item	Description	Condition	Cleanliness	Photos
5.1 General Overview	Clean and tidy. Neutral smell (no smoking or pet odours).	● Good	● Good	📷 9 photos
5.2 Skirting Board	For any marks, dents or dust please see pictures.	● Fair	● Good	📷 6 photos

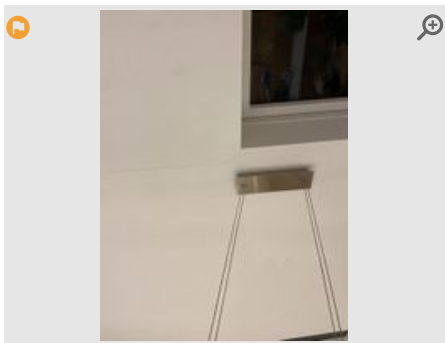
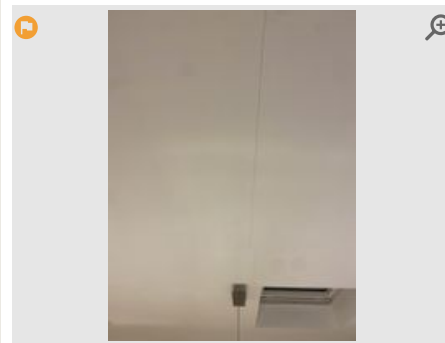
5.3 Ceiling	For any marks, mould or cobwebs please see pictures.	● Good	● Good	📷 2 photos
	<p>🚫 Disagreed by tenant - 6th December 2023 ● The inspector agreed</p> <p>Information provided by tenant Large crack in plaster from skylight to outside wall</p> <p>The inspector responded to the above tenant comments with the following: This is structural and isn't usually pointed out on an inventory.</p>

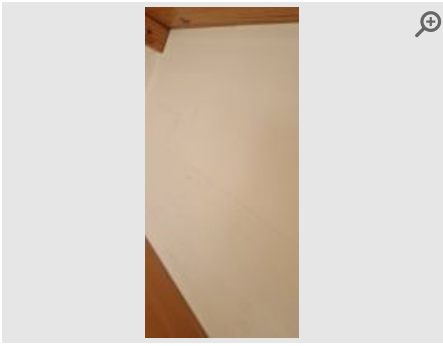
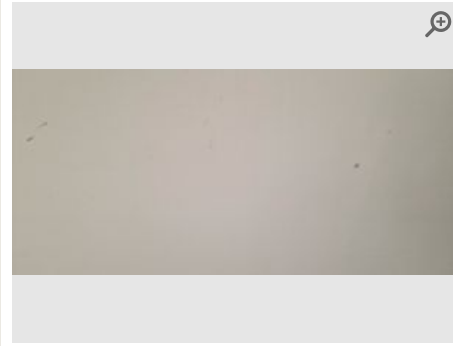
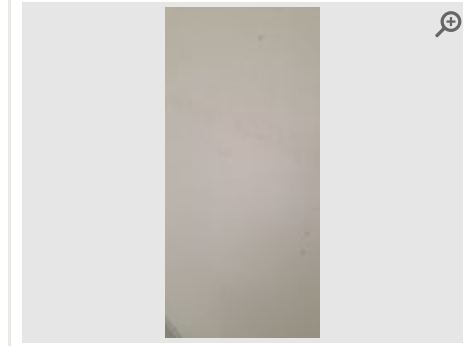
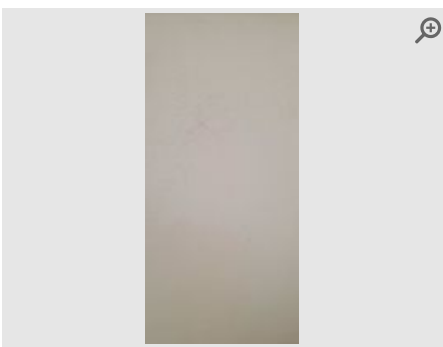
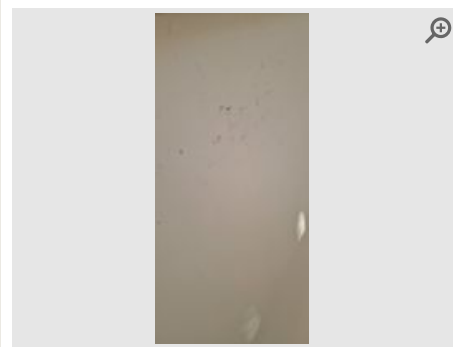
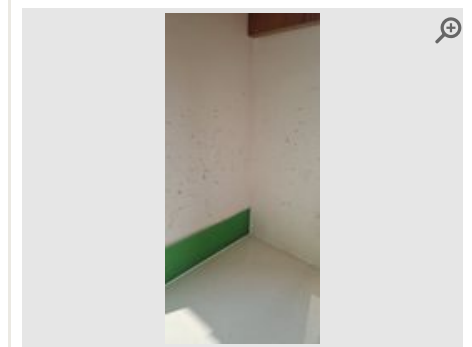
5.4 Light Fittings	No cobwebs present to light fittings. All bulbs in working order.	● Good	● Good	📷 1 photo
5.5 Walls	For any marks, stains, scuffs, picture hooks, raw plug or filled holes present please see pictures.	● Fair	● Good	📷 6 photos

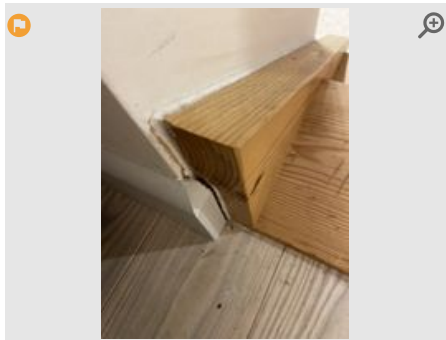
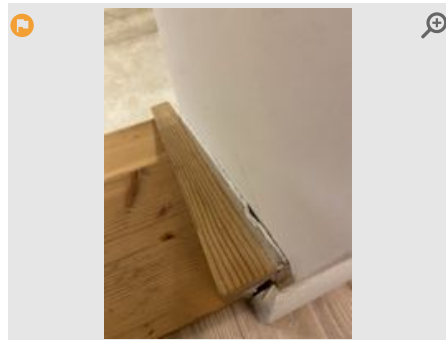
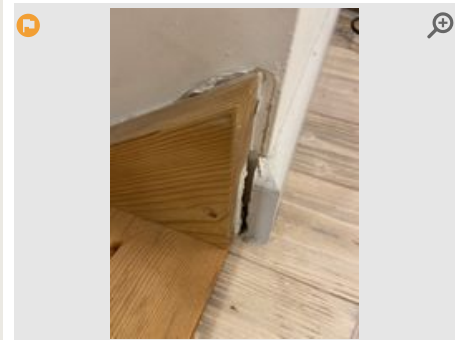
5.8 Floor	For any stains, marks, cracks, chips, scratches or indentations please see pictures.	● Fair	● Good	📷 10 photos
	<p>🚫 Disagreed by tenant - 6th December 2023 ● The inspector agreed</p> <p>Information provided by tenant Two wooden steps from lounge to kitchen are loose and move when stood on.</p>

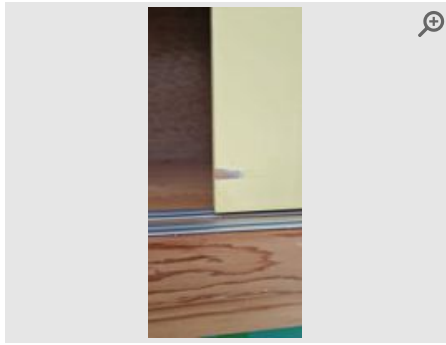
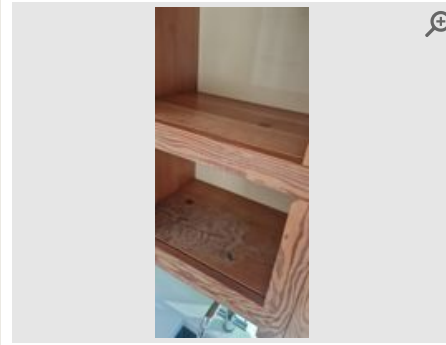
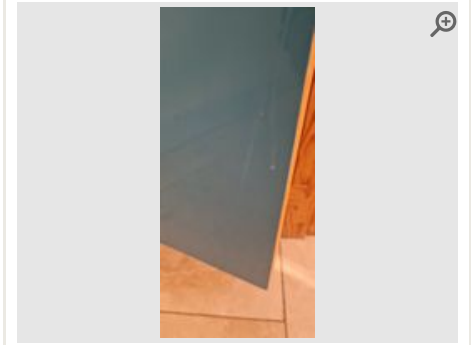
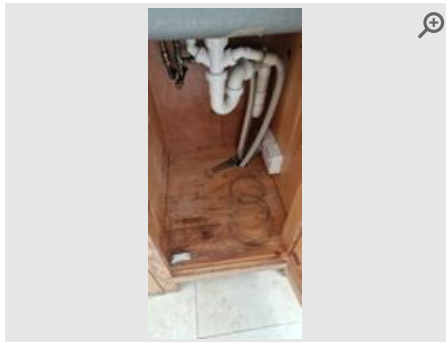
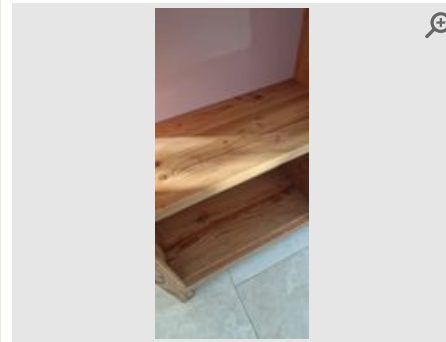
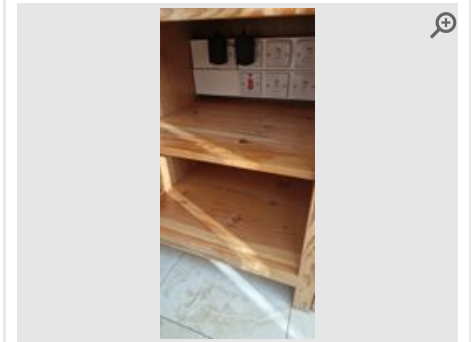
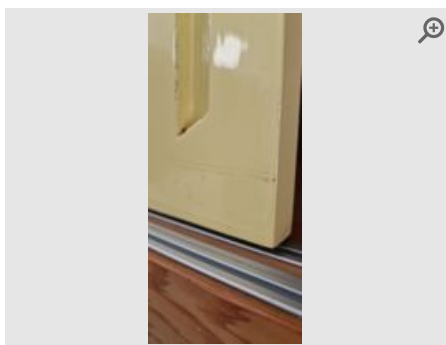
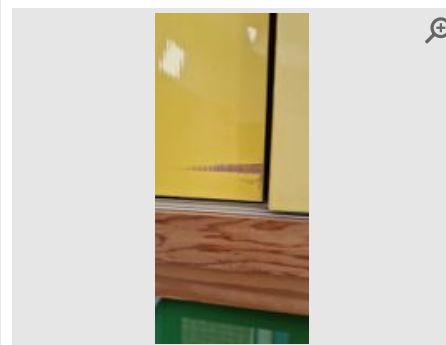
5.9 Kitchen Cupboards/Units	All handles and hinges intact. Free of items inside. Free of stains underneath sink. Free of grease and food residue inside.	● Fair	● Fair	📷 8 photos

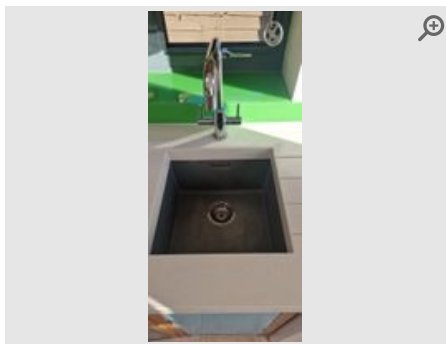
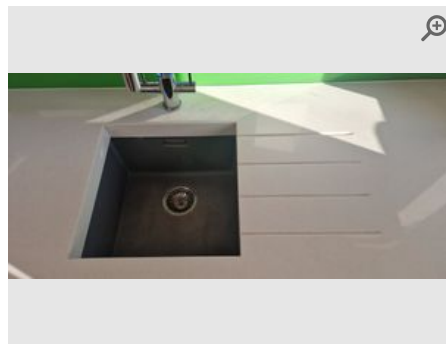
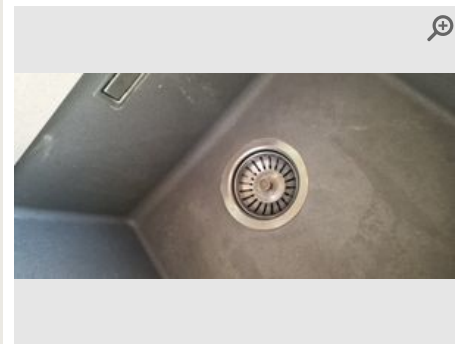
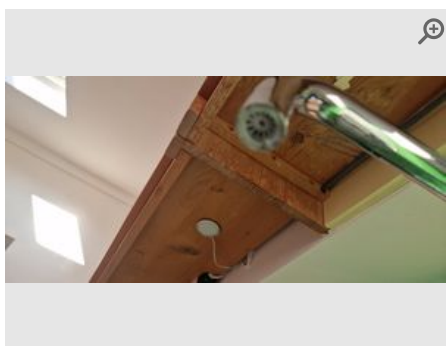
5.12 Kitchen Sink	Free of scratches and cracks. No food residue or grease present. Plug present.	● Good	● Good	📷 4 photos
5.13 Hob	Free of grease and food residue. Free of dust. Dials/knobs intact.	● Fair	● Good	📷 3 photos

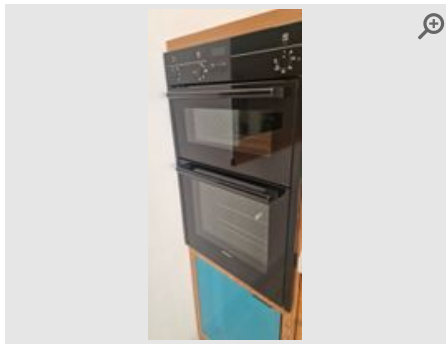
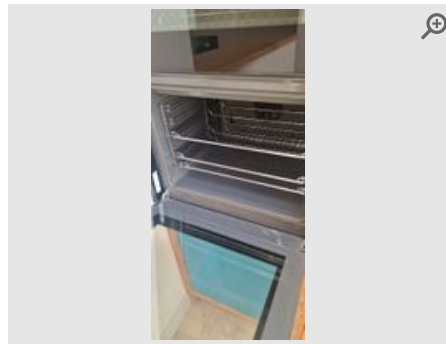
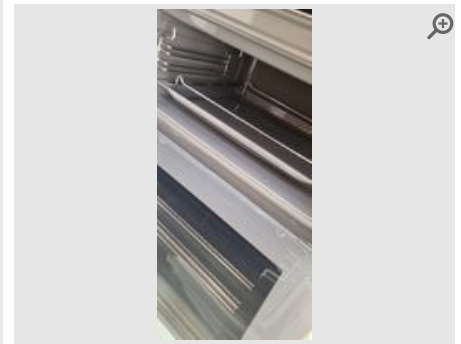
5.14 Oven	Free of grease and food residue inside. Seal intact and door hinge functioning smoothly.	● Good	● Good	📷 3 photos
5.15 Fridge	Clean and free of food residue inside. No cracks or damage to trays and shelving. Bulb in working order.	● Good	● Good	📷 8 photos
	<p>🚫 Disagreed by tenant - 6th December 2023 ● The inspector disagreed</p> <p>Information provided by tenant Fridge and freezer are separate. Scuff at top inside freezer</p>

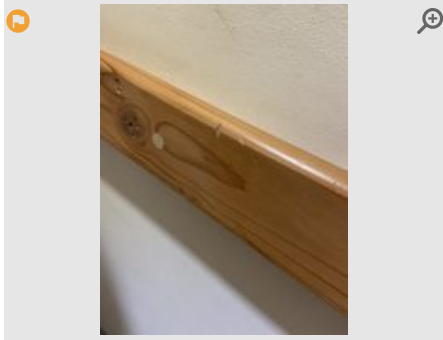
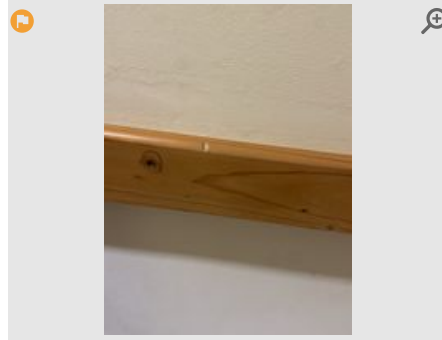
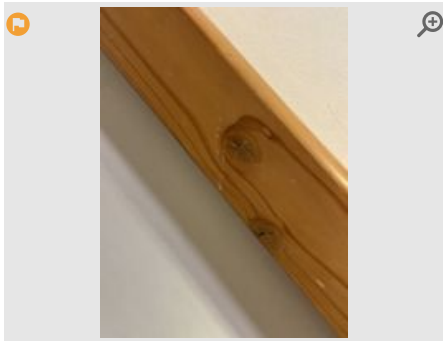
Provided by	Tenant
Captured (Certified by inspector)	01/12/2023
Added	06/12/2023
Reference	6.2.1

Item	Description	Condition	Cleanliness	Photos
6.1 General Overview	Clean and tidy. Neutral smell (no smoking or pet odours).	● Good	● Good	📷 9 photos
6.2 Bannister/Hand Rail	Appears securely fixed and intact. Free of marks and scratches.	● Good	● Good	📷 9 photos
	Disagreed by tenant - 6th December 2023		● The inspector agreed	
Information provided by tenant More marks and chips than documented

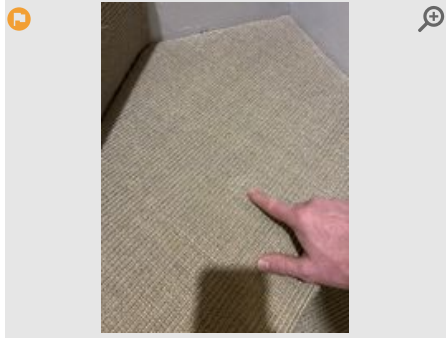
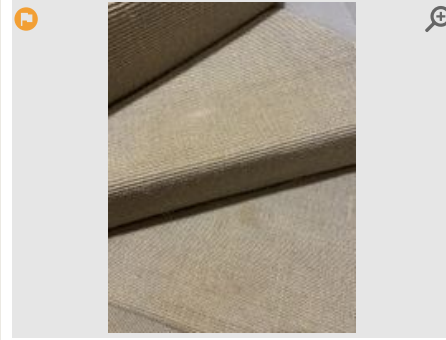
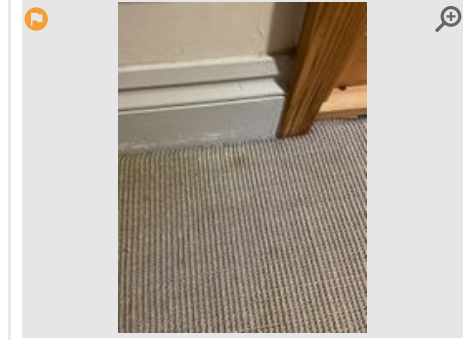
Provided by	Tenant
Captured (Certified by inspector)	01/12/2023
Added	06/12/2023
Reference	6.3.1

6.3 Floor	For any stains, marks, cracks, chips, scratches or indentations please see pictures.	● Good	● Good	📷 3 photos
	Disagreed by tenant - 6th December 2023		● The inspector agreed	
Information provided by tenant Some marks and stains to carpet

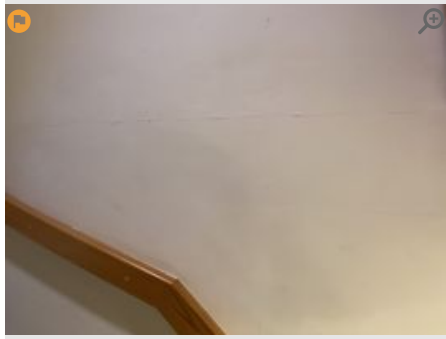
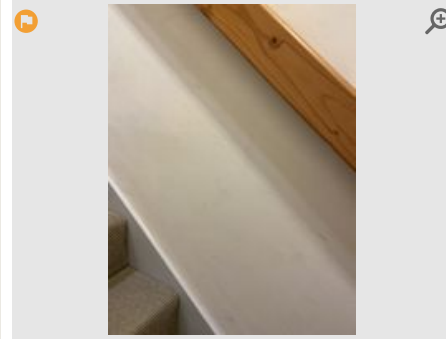
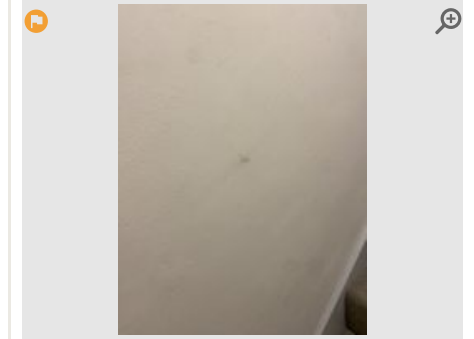
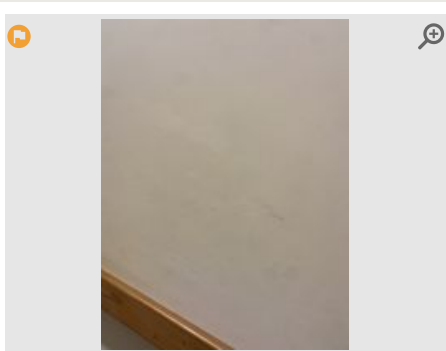
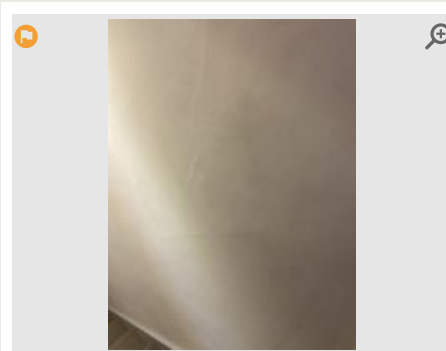
Provided by	Tenant
Captured (Certified by inspector)	01/12/2023
Added	06/12/2023
Reference	6.4.1

6.4 Walls	For any marks, stains, scuffs, picture hooks, raw plug or filled holes present please see pictures.	● Fair	● Good	📷 13 photos
	Disagreed by tenant - 6th December 2023		● The inspector agreed	
Information provided by tenant More marks, cracks and filled in holes than documented.

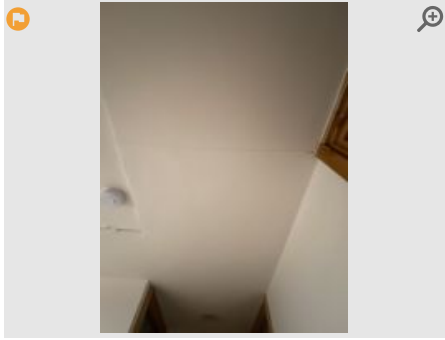
Provided by	Tenant
Captured (Certified by inspector)	01/12/2023
Added	06/12/2023
Reference	6.5.1

6.5 Ceiling	For any marks, mould or cobwebs please see pictures.	● Good	● Good	📷 1 photo
	Disagreed by tenant - 6th December 2023		● The inspector agreed	
Information provided by tenant Large crack from loft hatch to bedroom

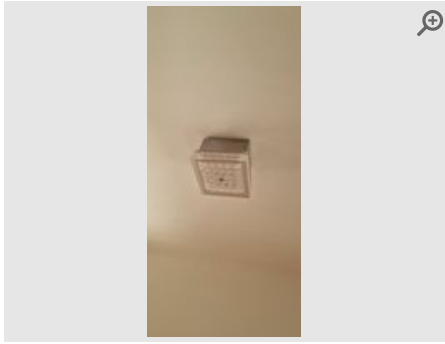
Provided by	Inspector
Captured (via App):	01/12/2023 11:57 AM
Added	01/12/2023
Reference	6.8.1

6.8 Light Fittings	No cobwebs present to light fittings. One bulb not in working order.	● Poor	● Good	📷 1 photo
6.9 Sockets & Switches	All sockets/switches plastic. 4 in total All sockets and switches present and intact with no signs of damage.	● Good	● Good	📷 N/A

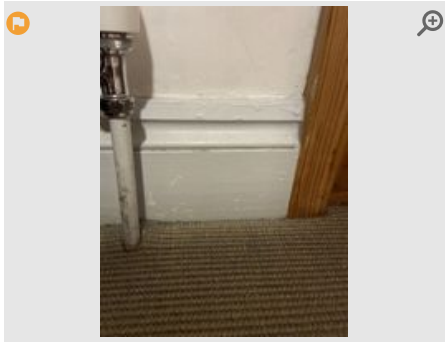
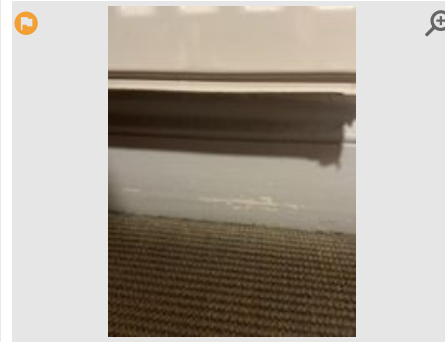
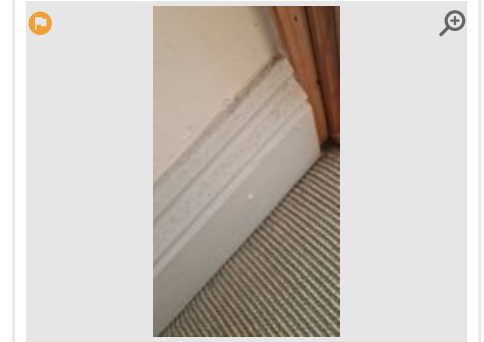
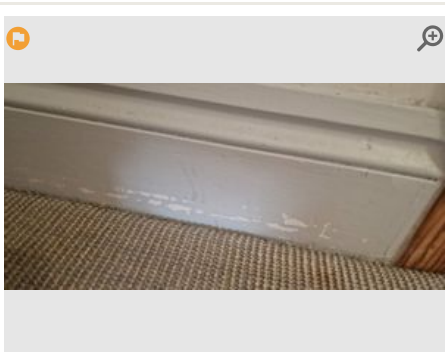
6.10 Skirting Board	Free of marks, dents and dust.	● Fair	● Fair	📷 4 photos
	Disagreed by tenant - 6th December 2023		● The inspector agreed	
Information provided by tenant Further photos of damage

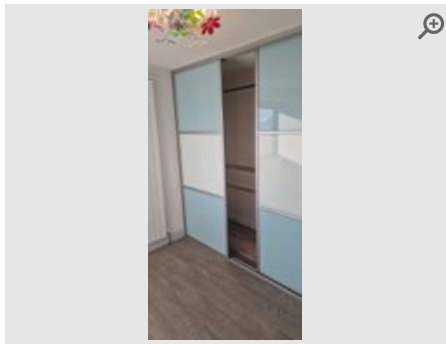
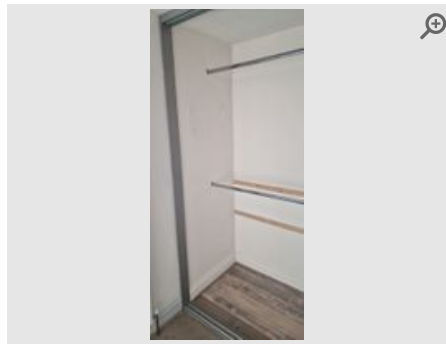
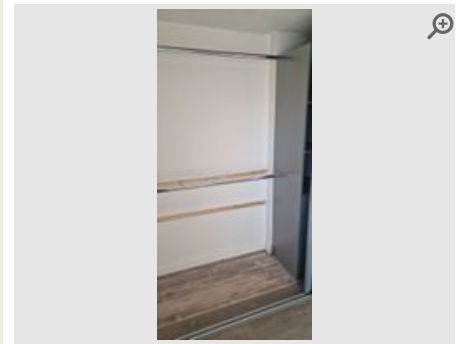
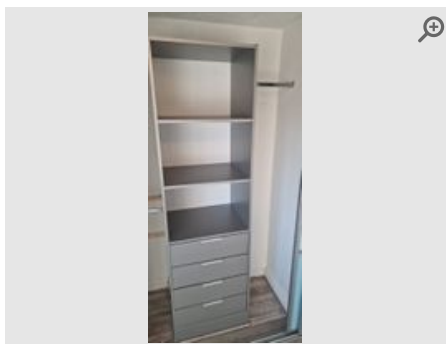
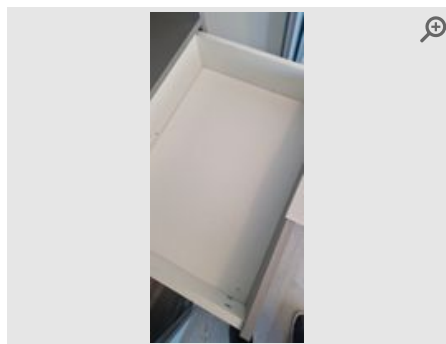
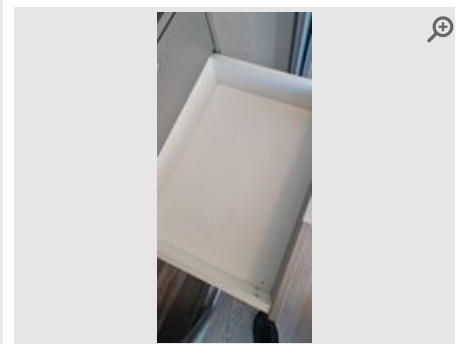
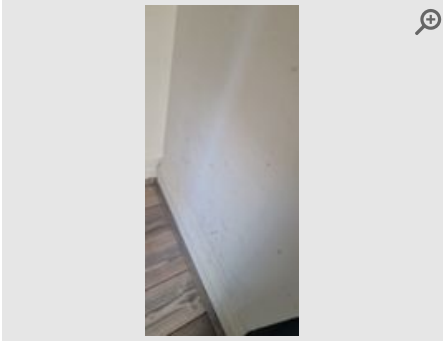
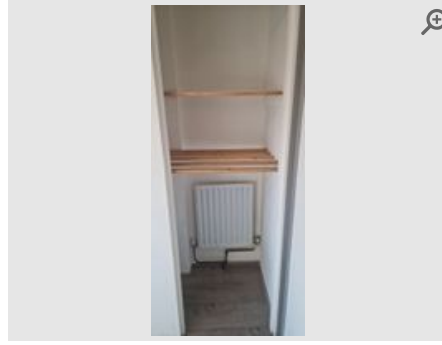
7.10 Floor	For any stains, marks, cracks, chips, scratches or indentations please see pictures.	● Good	● Good	📷 N/A
7.11 Storage Cupboard/Wardrobe	Free of marks and scratches to front side and reverse of door. Door hinges intact. Free of items and rubbish inside. Walls are heavily scuffed.	● Fair	● Good	📷 8 photos

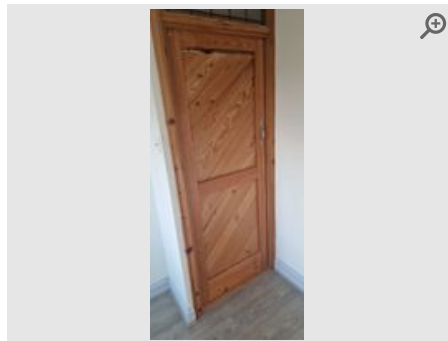
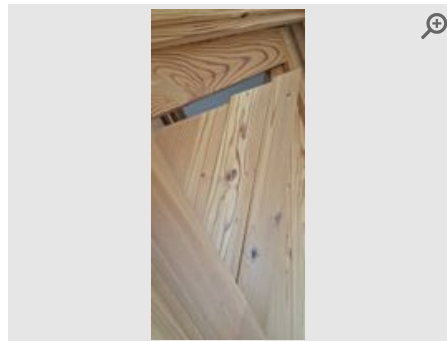
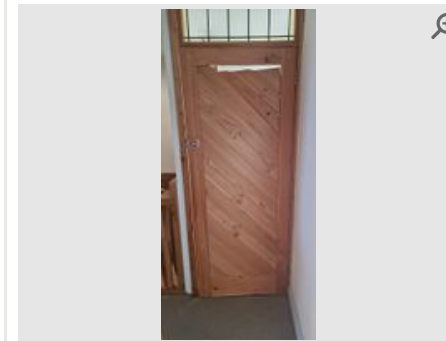
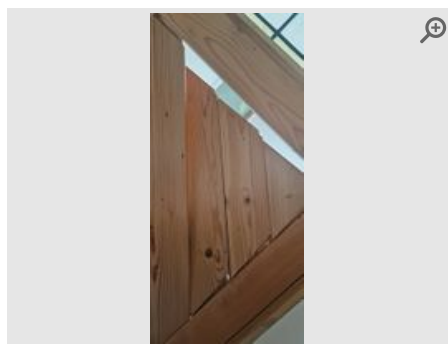
Item	Description	Condition	Cleanliness	Photos
8.1 General Overview	Clean and tidy. Neutral smell (no smoking or pet odours).	● Good	● Good	📷 9 photos
8.2 Door (Internal)	For any marks, scuffs or scratches to front side and reverse please see pictures.	● Very Poor	● Good	📷 4 photos

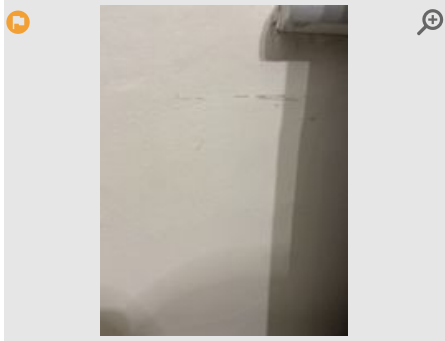
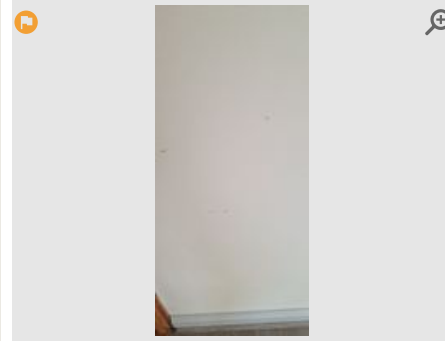
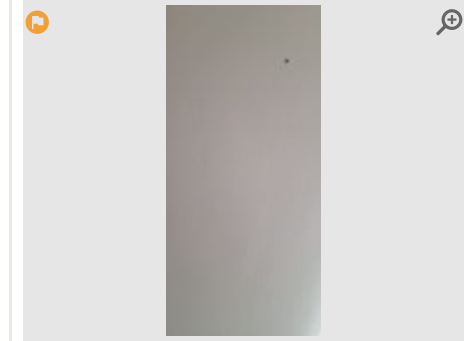
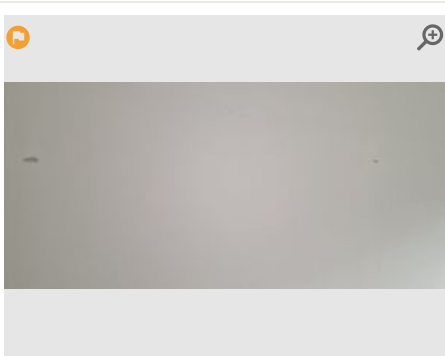
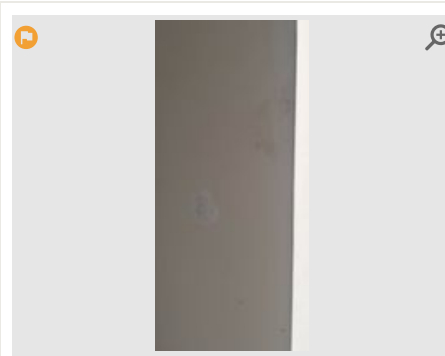
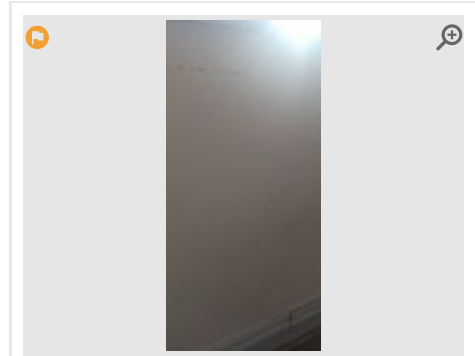
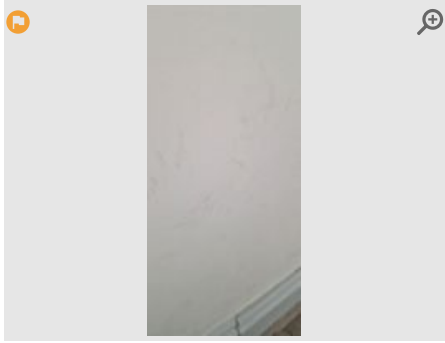
8.5 Light Fittings	No cobwebs present to light fittings. All bulbs in working order.	● Good	● Good	📷 N/A
8.6 Walls	For any marks, stains, scuffs, picture hooks, raw plug or filled holes present please see pictures.	● Fair	● Good	📷 7 photos
	<p>🚫 Disagreed by tenant - 6th December 2023</p> <p>Information provided by tenant Further photo of marks on wall near window</p>		● The inspector agreed

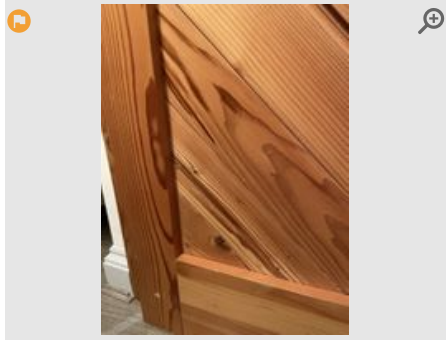
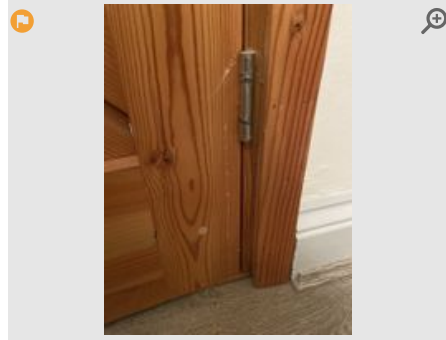
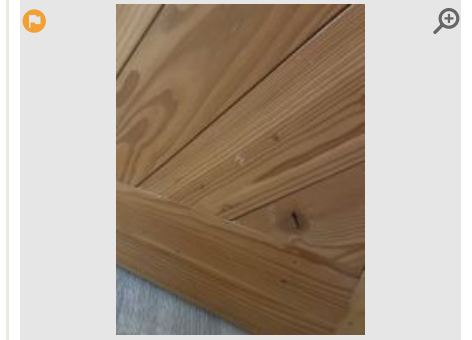
Item	Description	Condition	Cleanliness	Photos
9.1 General Overview	Clean and tidy. Neutral smell (no smoking or pet odours).	● Good	● Good	📷 8 photos
9.2 Door (Internal)	For any marks, scuffs or scratches to front side and reverse please see pictures.	● Good	● Good	📷 6 photos
	🚫 Disagreed by tenant - 6th December 2023 ● The inspector agreed Information provided by tenant Marks on outside of door and inside close to hinge

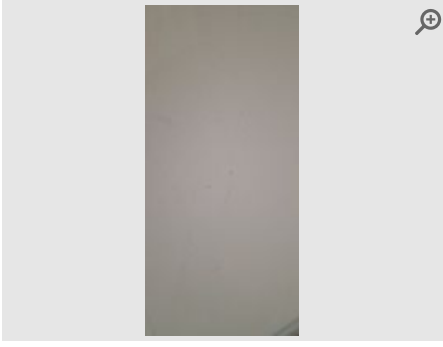
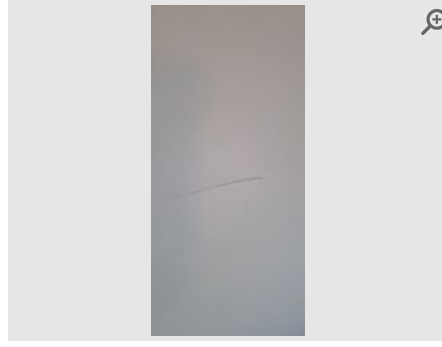
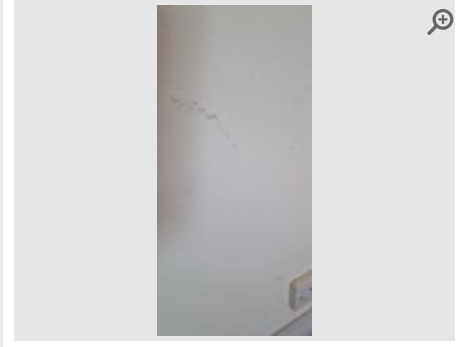
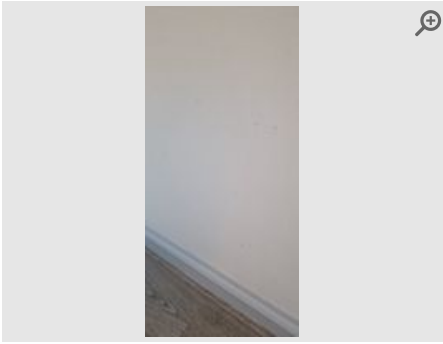
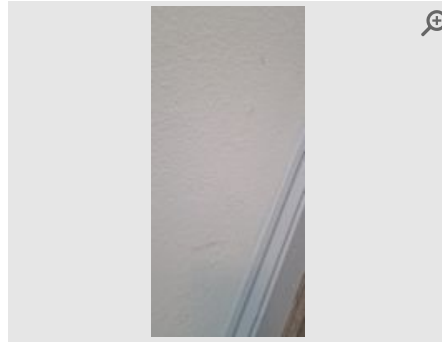
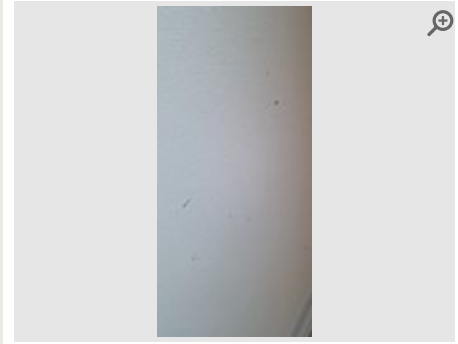
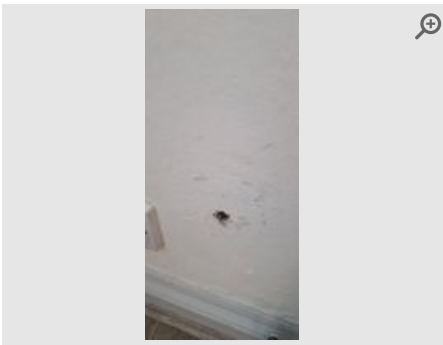
9.5 Light Fittings	No cobwebs present to light fittings. All bulbs in working order.	● Good	● Good	📷 N/A
9.6 Walls	For any marks, stains, scuffs, picture hooks, raw plug or filled holes present please see pictures.	● Fair	● Good	📷 7 photos

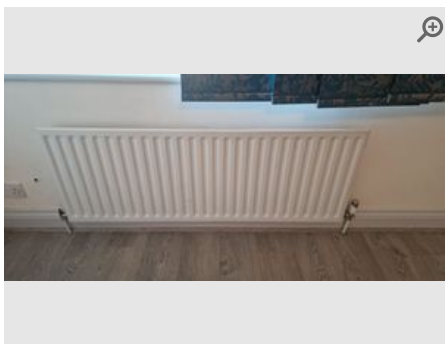
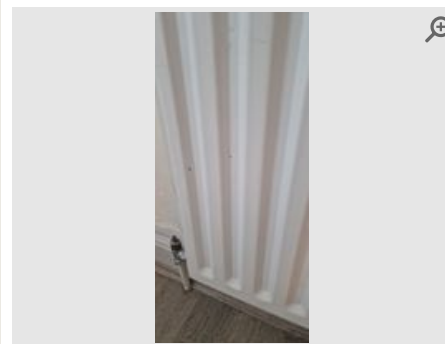
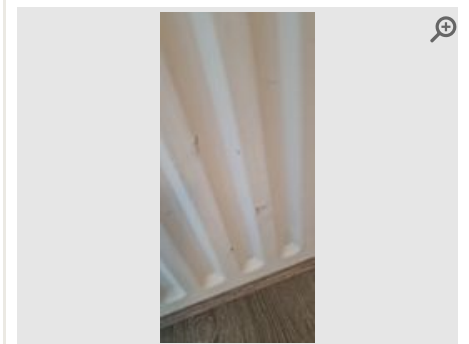
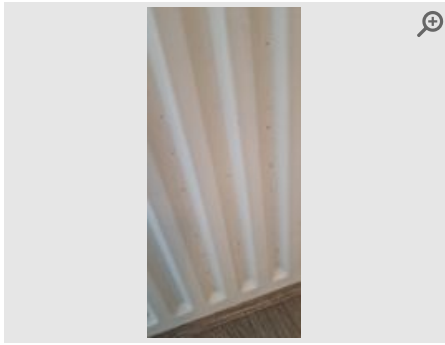
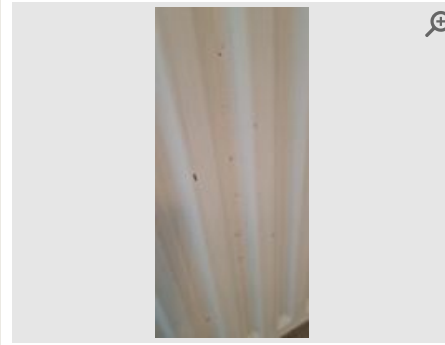
9.8 Radiator	Wall mounted radiator(s) for any marks or scuffs please see pictures. All valve caps present and intact.	● Fair	● Good	📷 5 photos
9.9 Sockets & Switches	All sockets/switches plastic. 4 in total All sockets and switches present and intact with no signs of damage.	● Good	● Good	📷 N/A

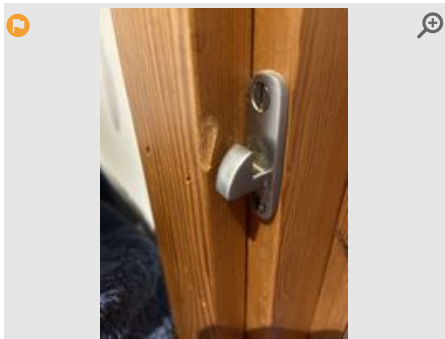
10.3 Door Frame & Skirting	For any marks, dents or dust please see pictures.	● Good	● Good	📷 3 photos
	<p>🚫 Disagreed by tenant - 6th December 2023</p> <p>Information provided by tenant Mark near catch and threshold is split and loose</p>		● The inspector agreed

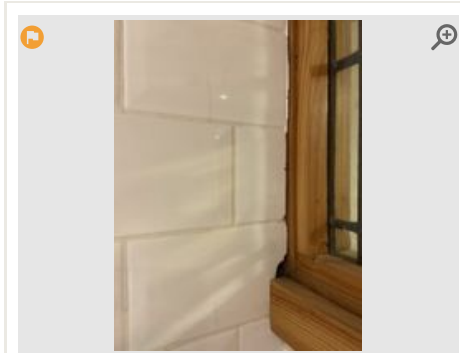
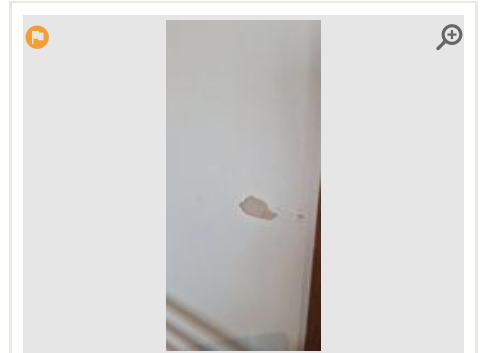
10.7 Switches/Cord	Present and intact.	● Good	● Good	📷 1 photo
10.8 Walls	For any marks, stains, scuffs, picture hooks, raw plug or filled holes present please see pictures.	● Good	● Good	📷 10 photos
	<p>🚫 Disagreed by tenant - 6th December 2023</p> <p>Information provided by tenant Tile near internal stained glass window is chipped. Some mould in grout around toilet cistern.</p>		● The inspector agreed

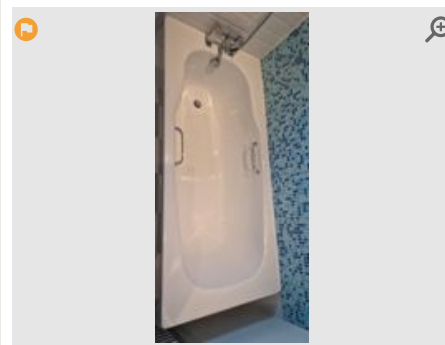
10.13 Bath	No gaps to bath sealant. Exterior panel intact. Clean and free of debris inside. Plug present.	● Good	● Good	📷 5 photos
	<p>🚫 Disagreed by tenant - 6th December 2023</p> <p>Information provided by tenant End bath panel is loose and cracked</p>		● The inspector agreed

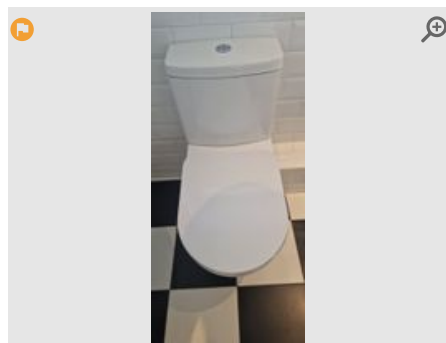
Item	Description	Condition	Cleanliness	Photos
10.15 Toilet	Free of cracks/chips. Flush intact. Seat secure and intact. Clean inside and to tank/base.	● Good	● Good	📷 4 photos
	🚫 Disagreed by tenant - 6th December 2023		● The inspector agreed	
	Information provided by tenant Toilet slow to empty when full flush is used			
10.16 Cabinet	Securely fixed to wall. Free of soiling/stains inside. Free of items inside. Hinges functioning well.	● Good	● Good	📷 5 photos
	🚫 Disagreed by tenant - 6th December 2023		● The inspector agreed	
	Information provided by tenant Marks on inside of cabinet doors and around frame			
10.17 Bathroom Fixings	Securely fixed.	● Good	● Good	📷 4 photos
	🚫 Disagreed by tenant - 6th December 2023		● The inspector agreed	
	Information provided by tenant Is not securely fixed with significant movement

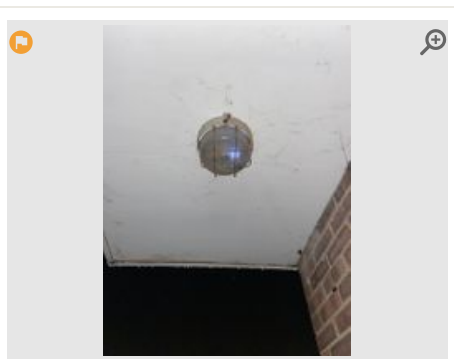
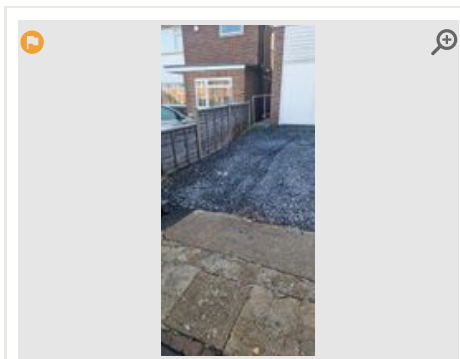
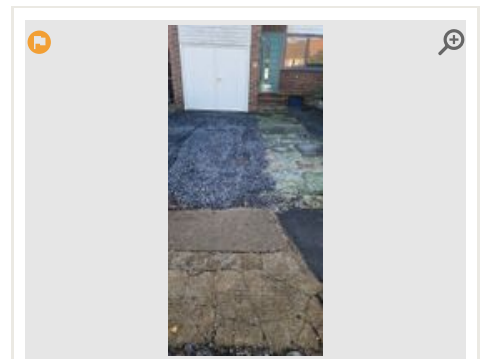
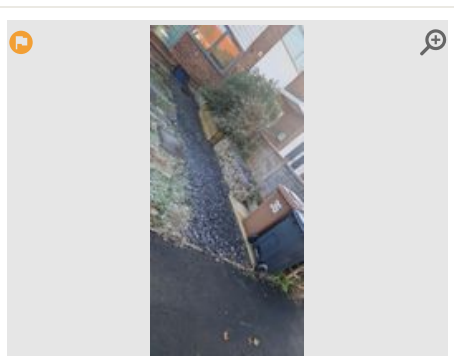
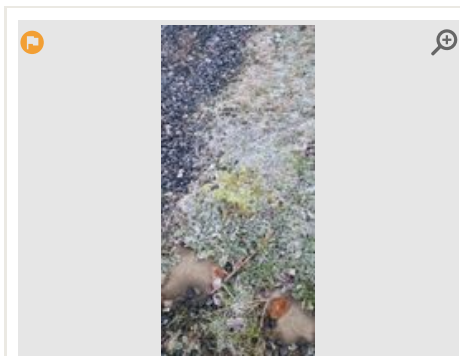
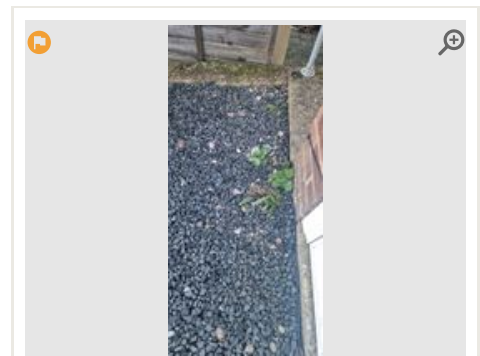
Item	Description	Condition	Cleanliness	Photos
11.1 Overview (External)	Numerous weeds present. Moss present. Gravel area. Block paved area Good seasonal order. Fencing appears secure. No rubbish present.	● Good	● Good	📷 6 photos
	🚫 Disagreed by tenant - 6th December 2023		● The inspector agreed	
	Information provided by tenant Front external light only partially working and very little light from it

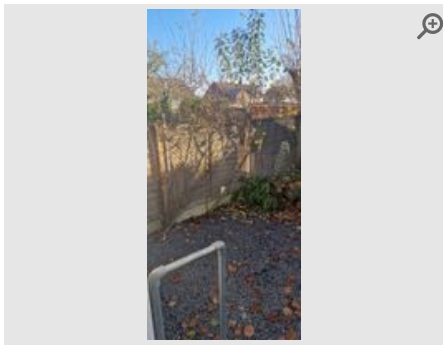
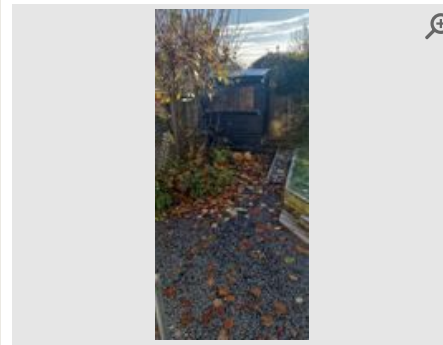
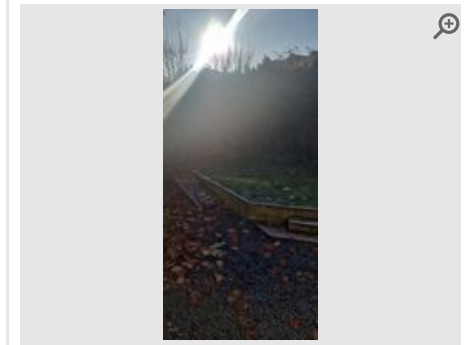
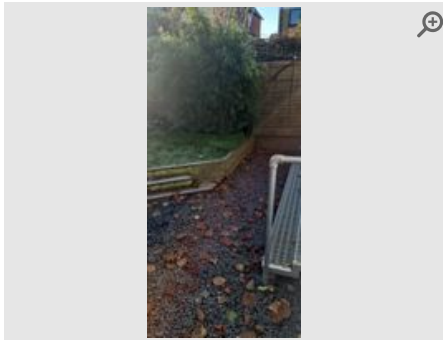
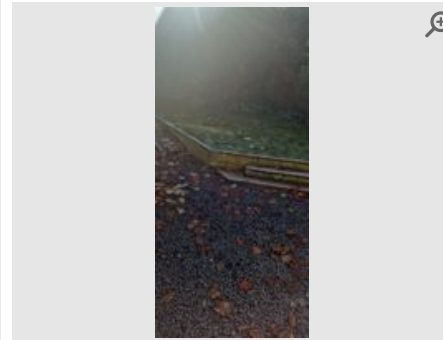
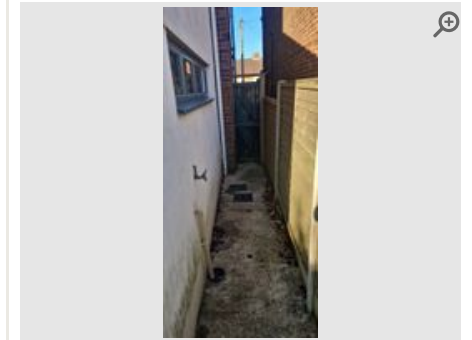
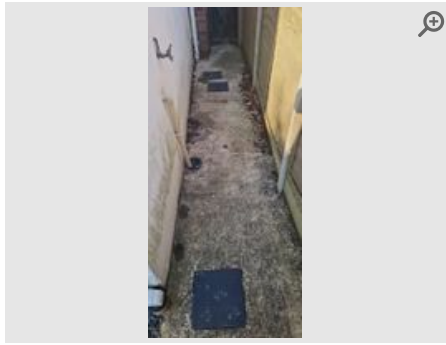
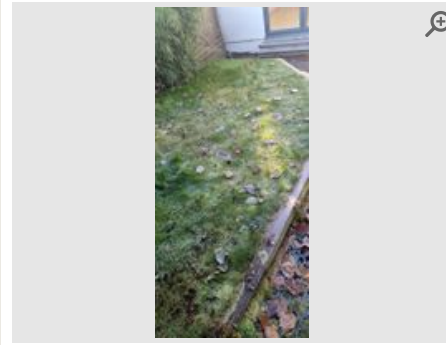
Item	Description	Condition	Cleanliness	Photos
12.1 Overview (External)	Numerous weeds present. Moss present. Overgrown plants. Overgrown shrubs. Gravel area. Paved area. Gate present Good seasonal order. Fencing appears secure. No rubbish present.	● Good	● Good	📷 8 photos
12.2 Shed	Hinged door with padlock present. Miscellaneous items present inside.	● Fair	● Good	📷 8 photos

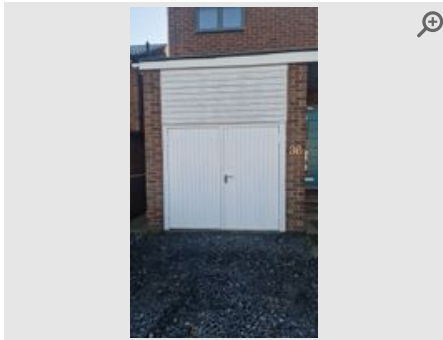
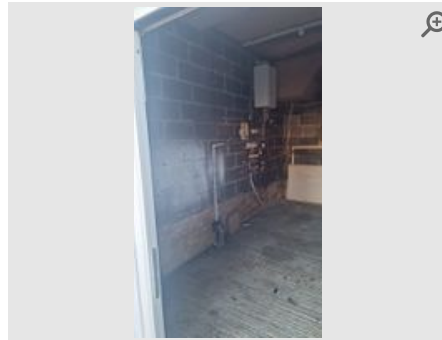
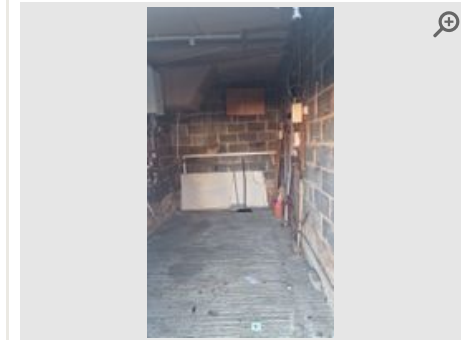
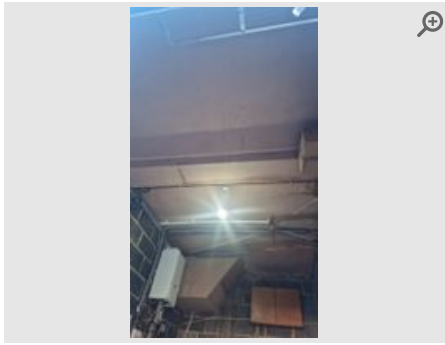
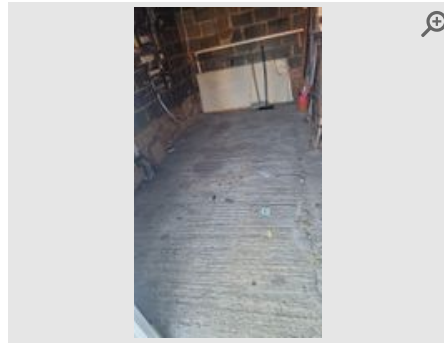
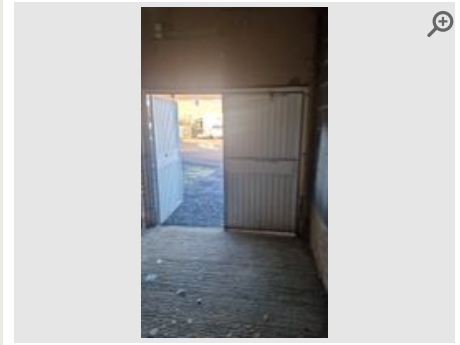
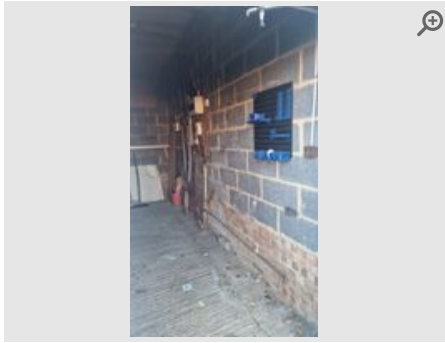
Item	Description	Condition	Cleanliness	Photos
13.1 Overview (Garage)	Miscellaneous items present inside. Garage door in working order.	● Good	● Fair	📷 7 photos
13.2 Door (Internal)	For any marks, scuffs or scratches to front side and reverse please see pictures.	● Good	● Poor	📷 5 photos
13.3 Floor (Garage)	Debris and oil stains present.	● Good	● Poor	📷 3 photos
13.4 Walls (Garage)	Paint stains present.	● Fair	● Fair	📷 N/A
13.5 Ceiling (Garage)	Intact and free of damage.	● Good	● Good	📷 N/A
13.6 Sockets & Switches	All sockets/switches mixed metal/plastic. 6 in total All sockets and switches present and intact.	● Good	● Good	📷 N/A
13.7 Light Fittings	All bulbs in working order.	● Good	● Good	📷 N/A
